Virginia City Highlands Property Owners Assoc.

Level 1 Reserve Study

Report Period - 7/1/2014 to 6/30/2015

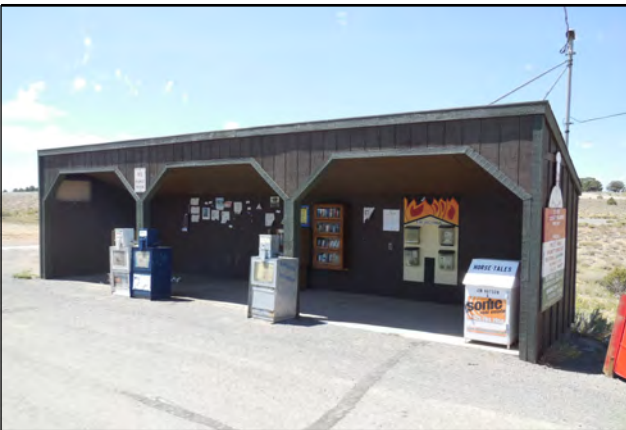
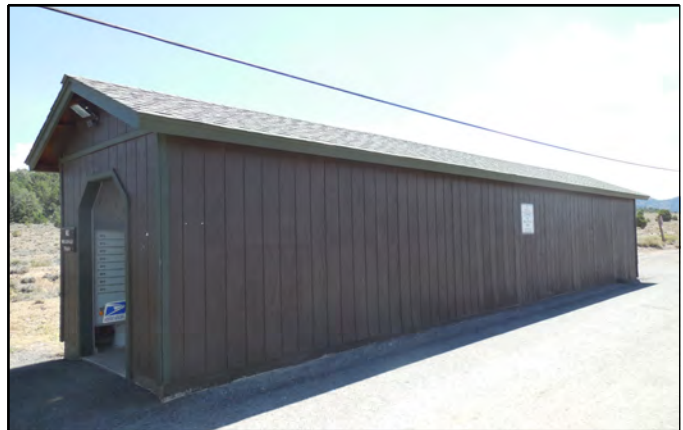
Painted surfaces are in good condition. No appearance concerns or paint loss noted at the time of inspection. Remaining life based on current condition.

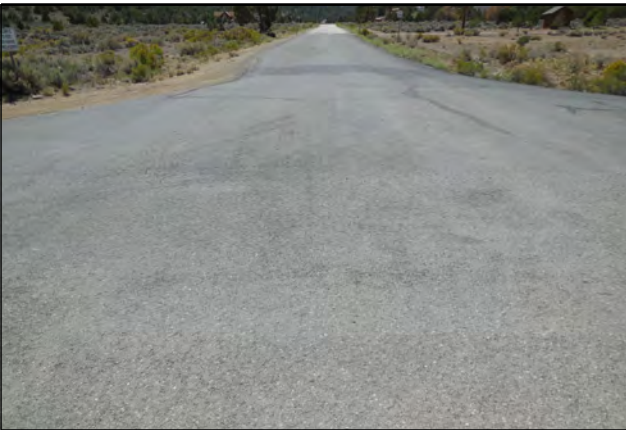
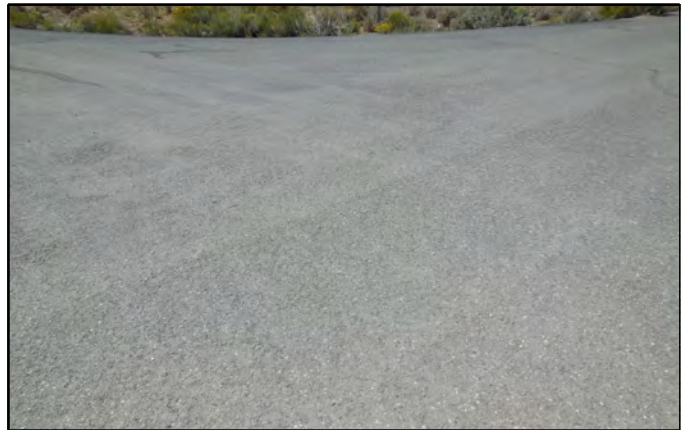
Comp # 401 Roadwork - Rebuild

Per client, this community rebuilds approximately 1 mile of road every year.

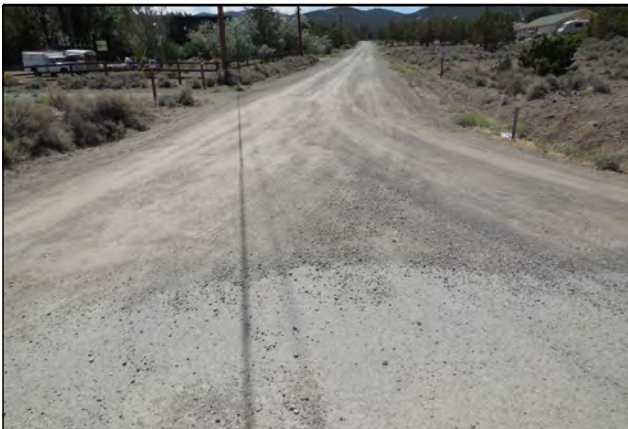
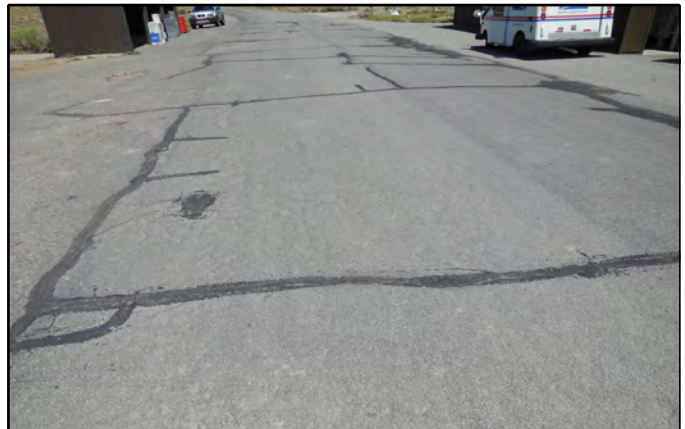
Comp # 402 Roadwork - Maintenance

Client reports that maintenance will include maintaining all 14 miles of roads and applying dust suppressant/road stabilization materials to approximately 7 miles of roads (5 miles of major gravel roads and 2 miles of secondary roads as needed).

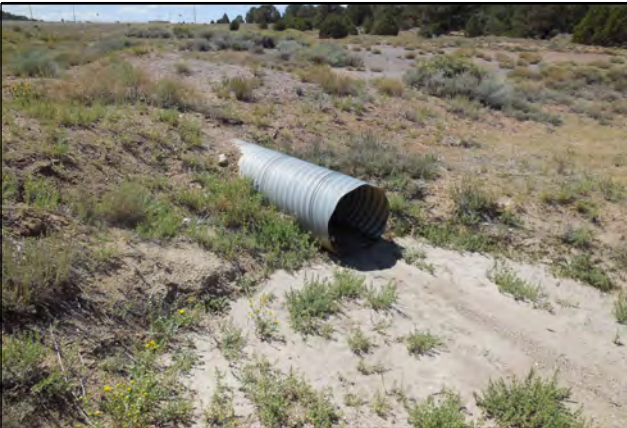
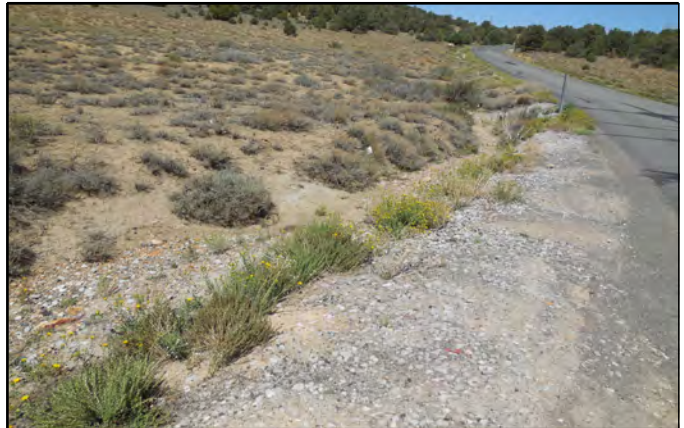
Comp # 406 Culverts/Ditches - Repair

We recommend funding to make similar repairs approximately every three years. Remaining useful life based on current schedule.

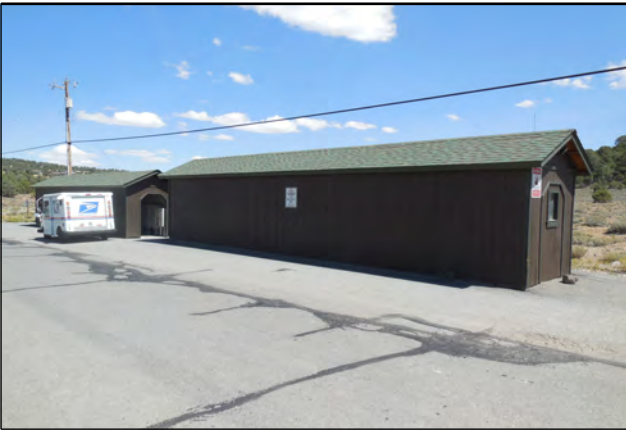
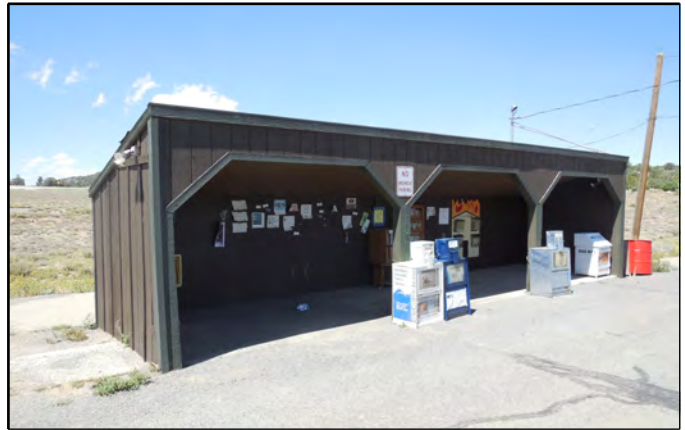
Comp # 590 Community Structures - Refurbish

No expectation to completely replace the mailbox structures. We recommend funding to replace the roofs and to significantly repair the structures approximately every 15 years. Client reports that these structures are shared with the neighboring community. Because the maintenance of these structures is shared we have funded for this project at 50% of the total cost

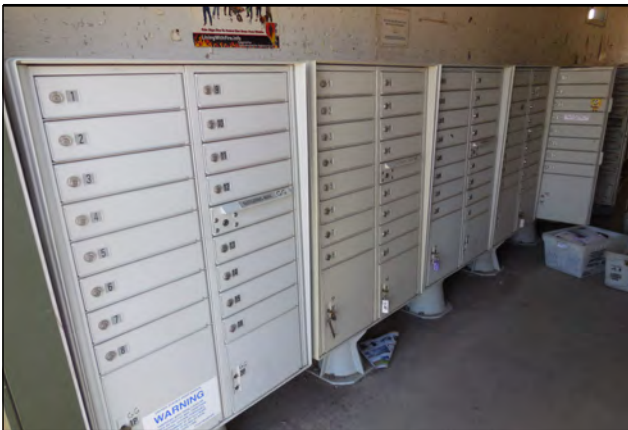
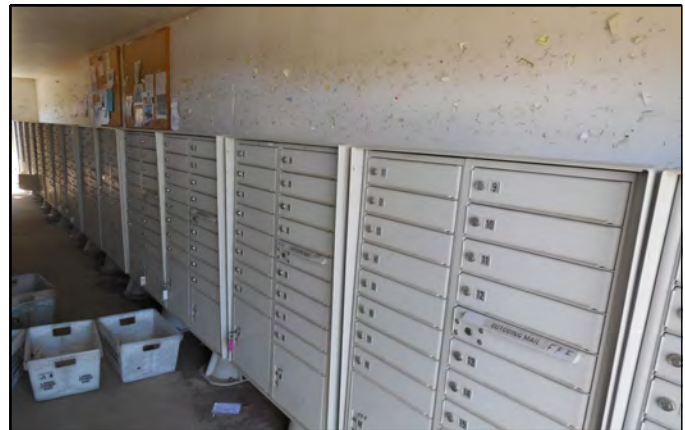
Comp # 803 Mailboxes - Replace

Mailboxes are in good condition. No significant signs of wear or age noted. Client reports that these mailboxes are shared with two other communities. We have therefore funded for 1/3 of the replacement cost.

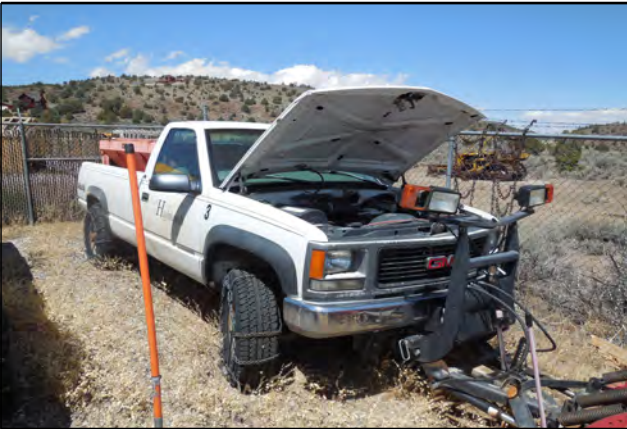
Comp # 1901 Pick-Up Truck - Replace (2000)

No problems noted or reported. Expect a total life of approximately 15 years from this type of vehicle. We have assumed future vehicles will be purchased used and approximately 4 years old. Remaining life based on current age.

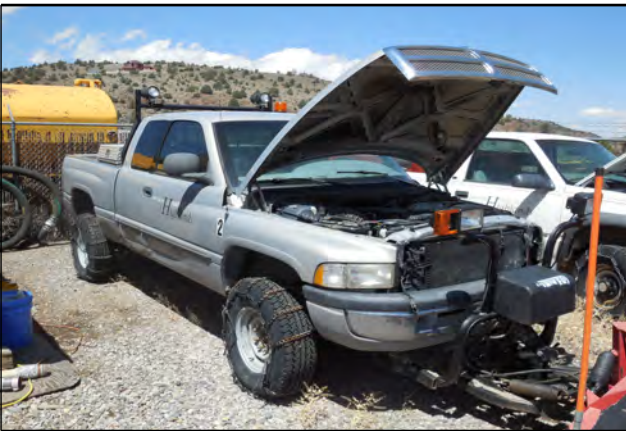
Comp # 1901 Pick-Up Truck - Replace (2001)

Client reports that this vehicle was purchased in 2005. Expect a total life of approximately 15 years from this type of vehicle. We have assumed future vehicles will be purchased used and approximately 4 years old. Remaining life based on current age.

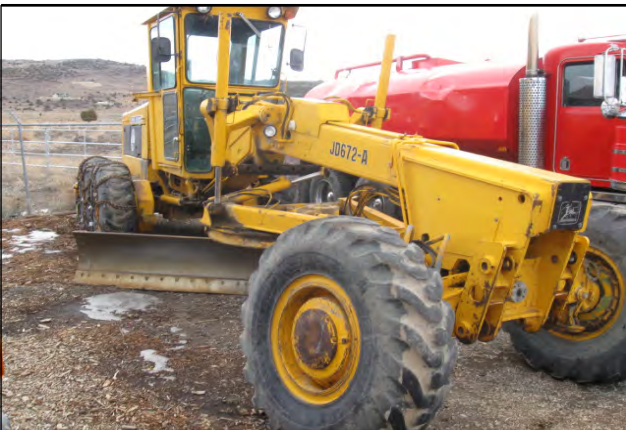
Comp # 1903 Grader - Replace

Grader is older but in fair condition. Remaining useful life is based on current age and condition, but may realize an extended useful life with proper maintenance.

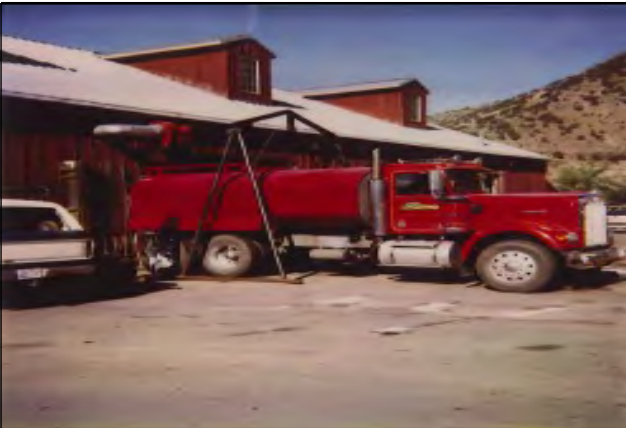
Comp # 1904 Water Truck - Replace

Water truck is in good condition. No reports of problems at the time of inspection. Remaining useful life based on current age and condition.

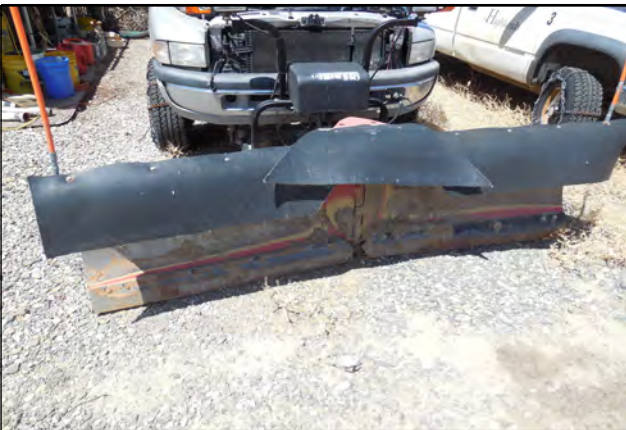
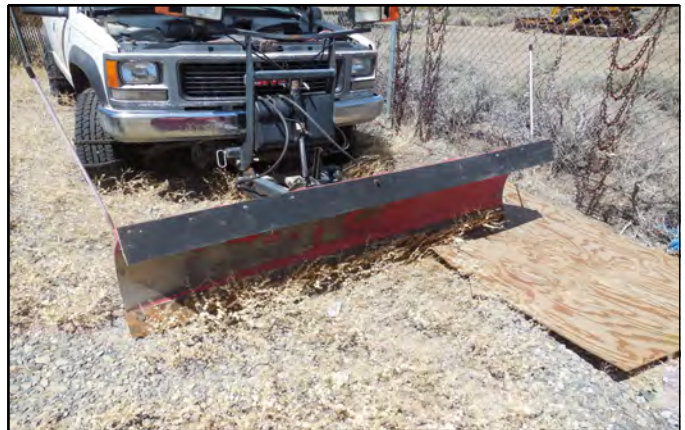
Comp # 1905 Blades - Replace

These blades were purchased in 2005. expect a useful life of approximately 12 years from these blades. Remaining life based on current age.

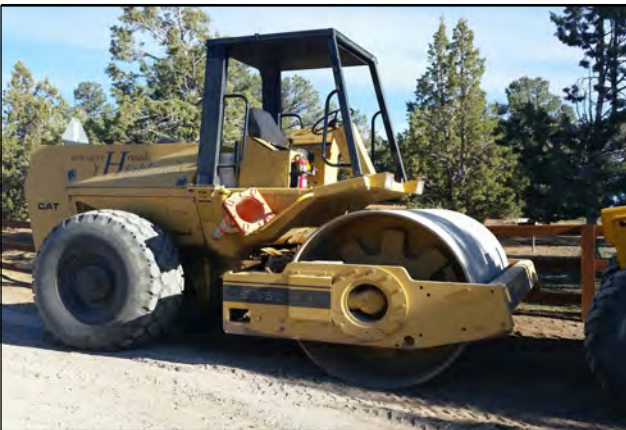
Comp # 1906 Caterpillar Roller - Replace

Per client, this community purchased this equipment in 2010. We recommend funding to replace this component approximately every 15 years.

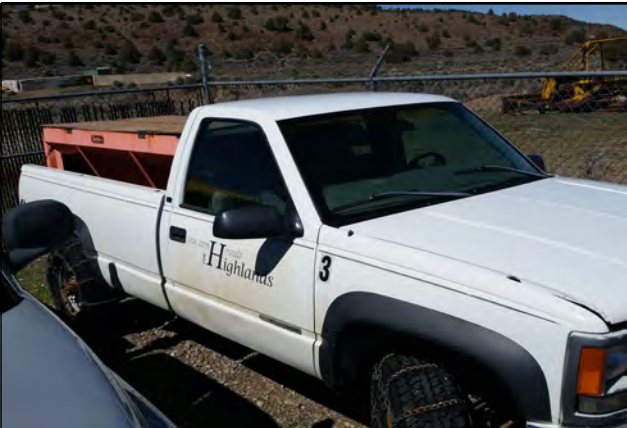
Comp # 1907 Sander/Salt Spreader - Replace

No problems with this equipment reported. We recommend funding to replace this component approximately every 20 years.

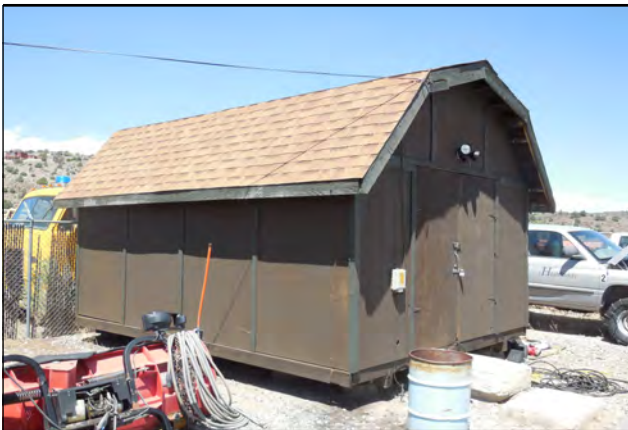
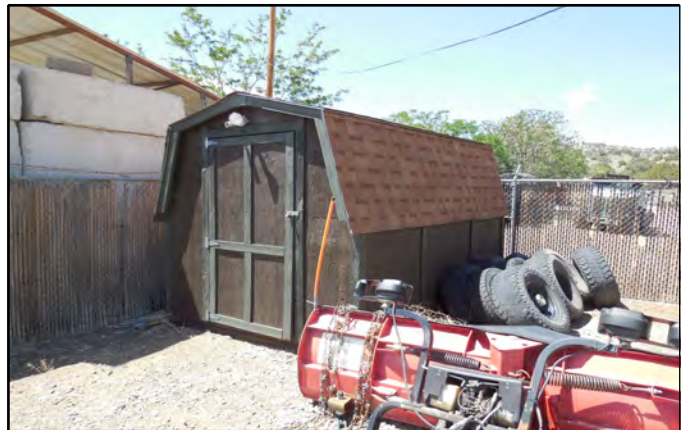
Comp # 1990 Utility Sheds - Repaint/Repair

We recommend funding to repaint and repair these utility sheds approximately every 5 years. Remaining useful life based on current age and condition.
